DEPARTMENT: MINERALS AND ENERGY
REPUBLIC OF SOUTH AFRICA
MPUMALANGA REGION
TEL: 013 – 656 1448
FAX: 013 – 6903288

NEWSLETTER MPUMALANGA REGION APRIL / MAY 2007

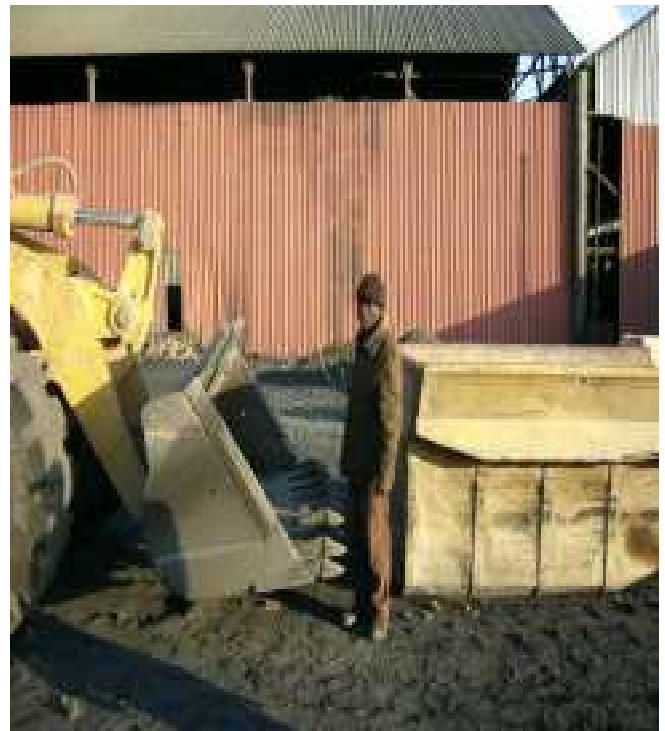
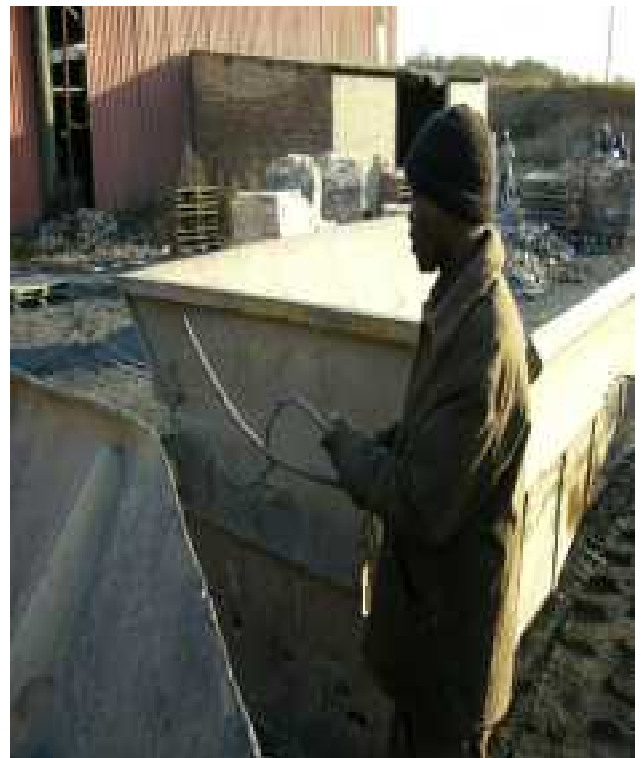
Simulation of accident

At about 09:30, a tractor driver was seriously injured when his body was caught between the bucket teeth of a CAT front-end-loader and a Telekon container in a brick yard. The then-injured succumbed to his injuries in hospital later the same day.

1. The Telekon trailer had a flat wheel and could not be used to carry the container. This trailer is generally attached to a tractor when in use.
2. The Telekon container was used to convey broken and reject bricks from the brick-making section to an allocated dump site.
3. The now-deceased, being the tractor driver, approached the front-end-loader driver to assist in transporting the container to the dump site. He attached a steel wire sling to the two front hooks on the container, and whilst attempting to hook the sling onto some of the front-end-loader bucket teeth, his body was caught between the bucket teeth and the container.

1. The correct equipment, being the Telekon trailer, was not available at the time of the accident.
2. An inappropriate mobile machine was used in an attempt to transport the container.
3. The now-deceased was in a precarious position whilst attempting to attach the sling to the front-end loader bucket teeth.
4. The front-end-loader engine was running and the machine was being manoeuvred at the time of the accident.

1. Care must be taken to ensure that only the correct equipment is used for any high-risk task.
2. Regular planned-task observations need to be conducted on all employees involving all high-risk tasks.
3. Employers need to ensure that all employees carry out mini risk assessments before commencement of any work where there may be a risk, especially when doing out-of-the-ordinary work.
