# SWC Dawid Brown Catastrophic Failure

21 January 2010

Compiled by: P.J. Du Preez

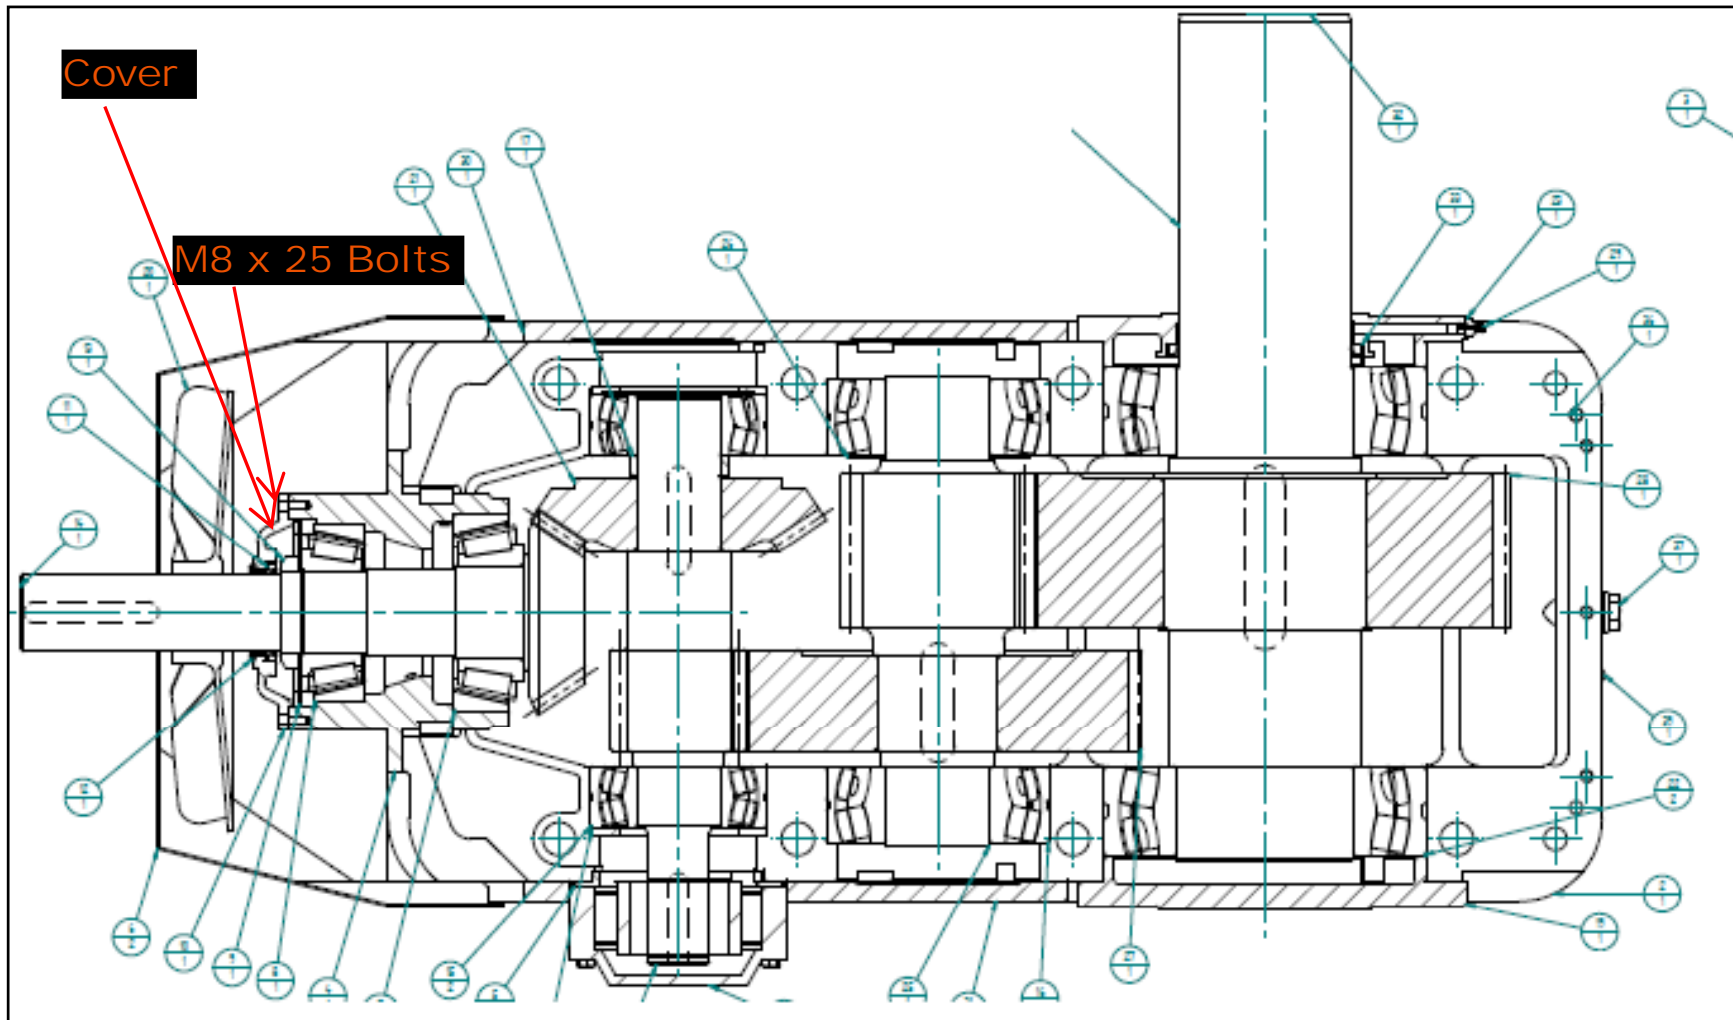
# Detail Drawing

- 
- History of Gearbox
    - It was 7 Months (4704 Hrs) in service.
    - Gearbox was assembled at DB.
    - According to DB assembly QC list there was a certain length of bolt (M8 x 25) to be used to secure the input pinion Bearing oil cove of the gearbox. This was not done. A different length of bolt (M8 x 16) was used.
    - The bearing is a thrust bearing. The thrust causes a dynamic condition. In order to prevent the cover from vibrating loose 25mm bolts should be used.
    - Good Engineering practice is to use lock tight on the bolts.

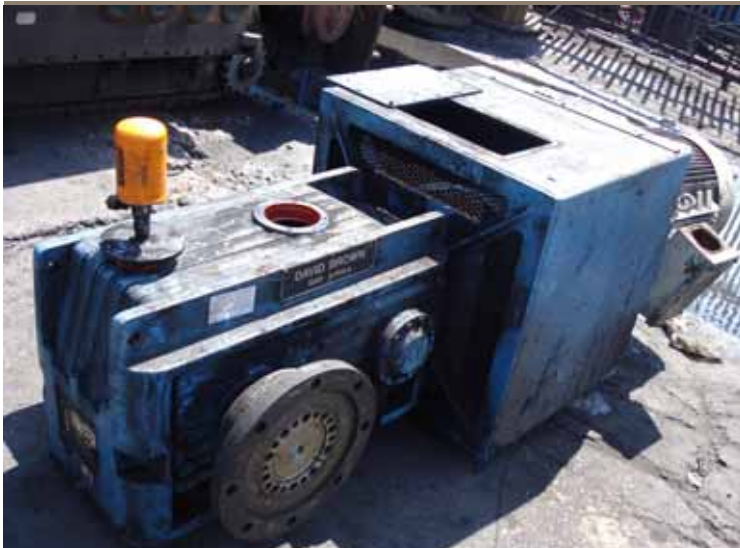
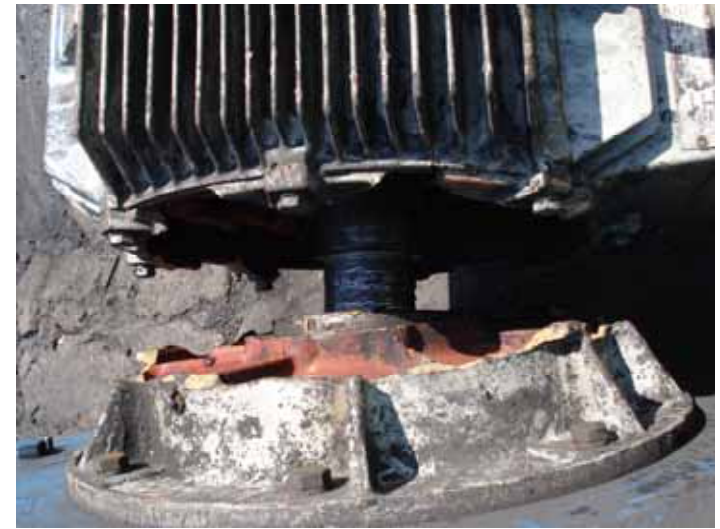
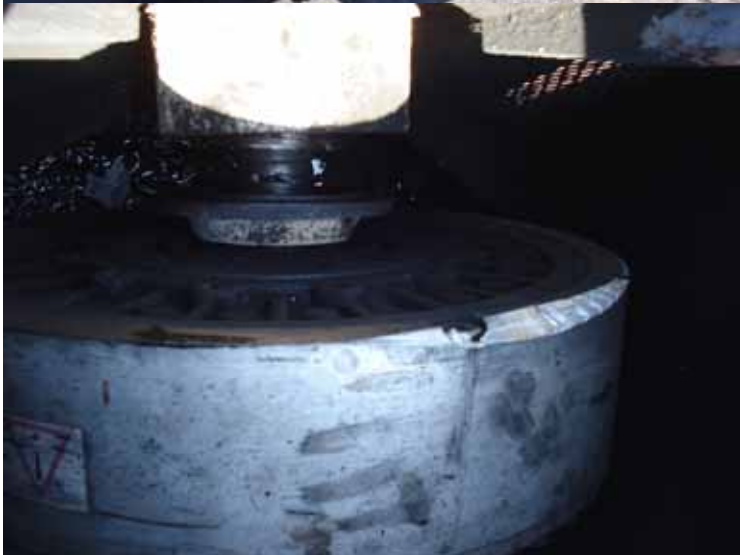
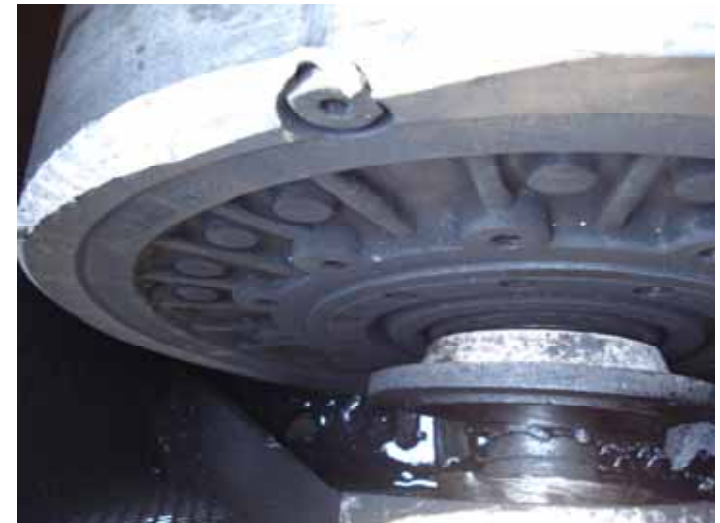
# Photos Before investigation

- Time lapse between identifying high temperature and failure was 15 min.
- The following were discovered
  - The Motor was sheared off, the fluid drive coupling housing was also sheared off and the fluid drive coupling were hanging skew from the gearbox.

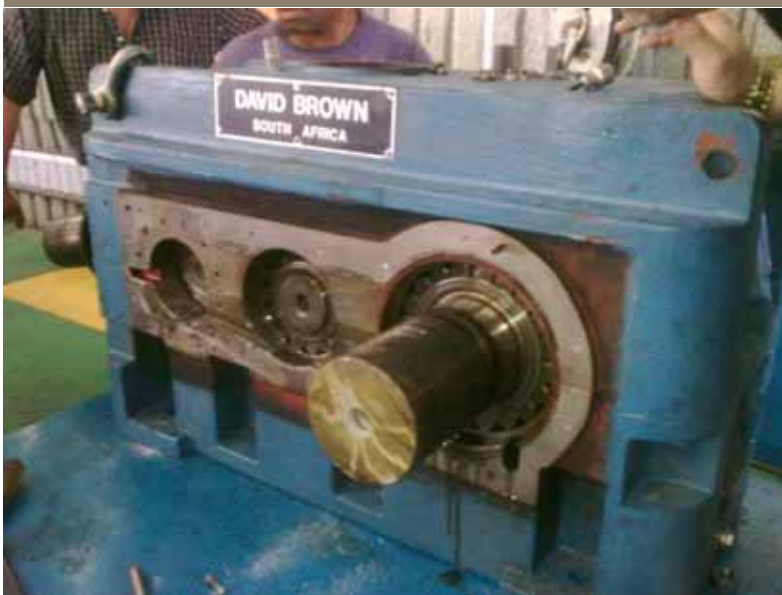
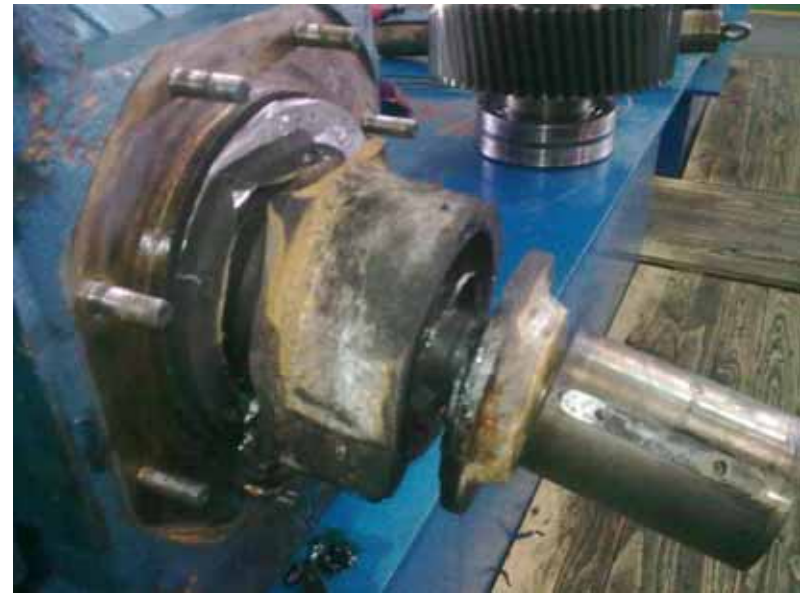
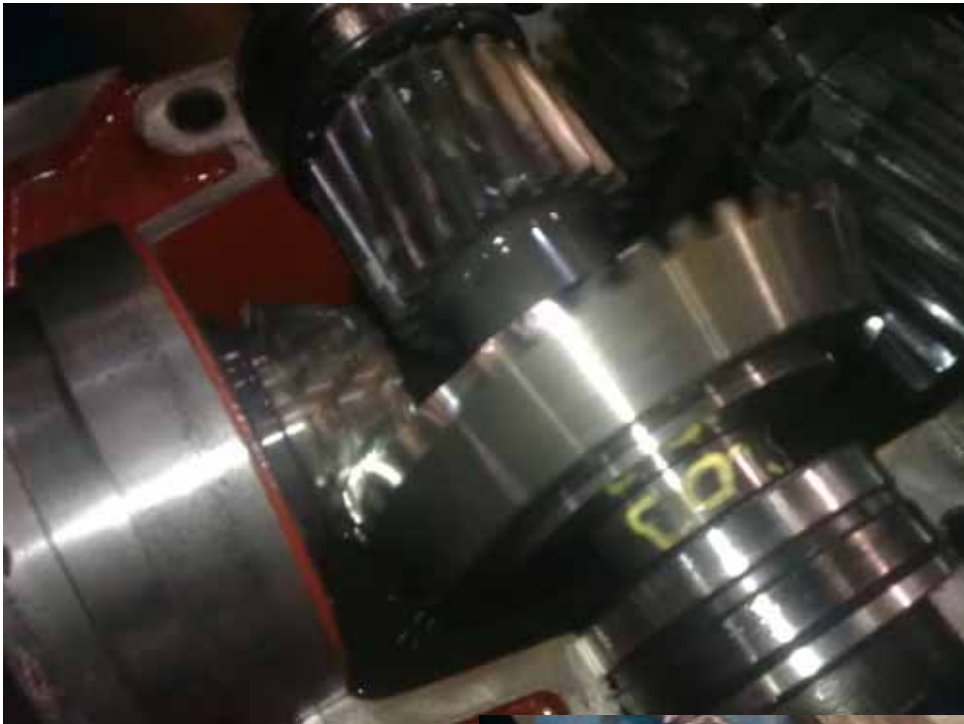
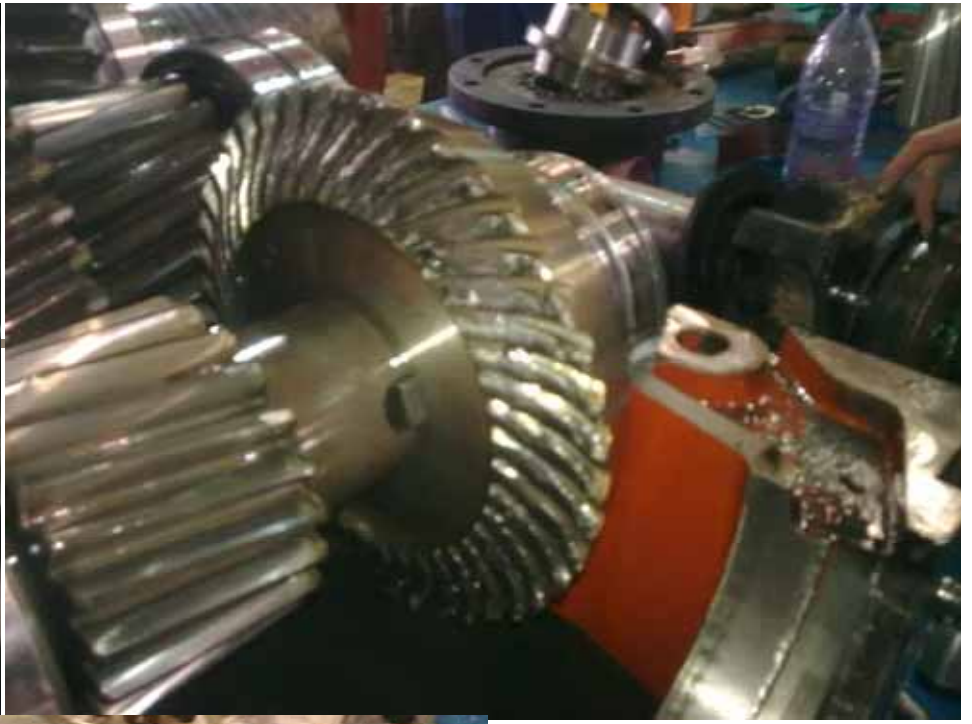
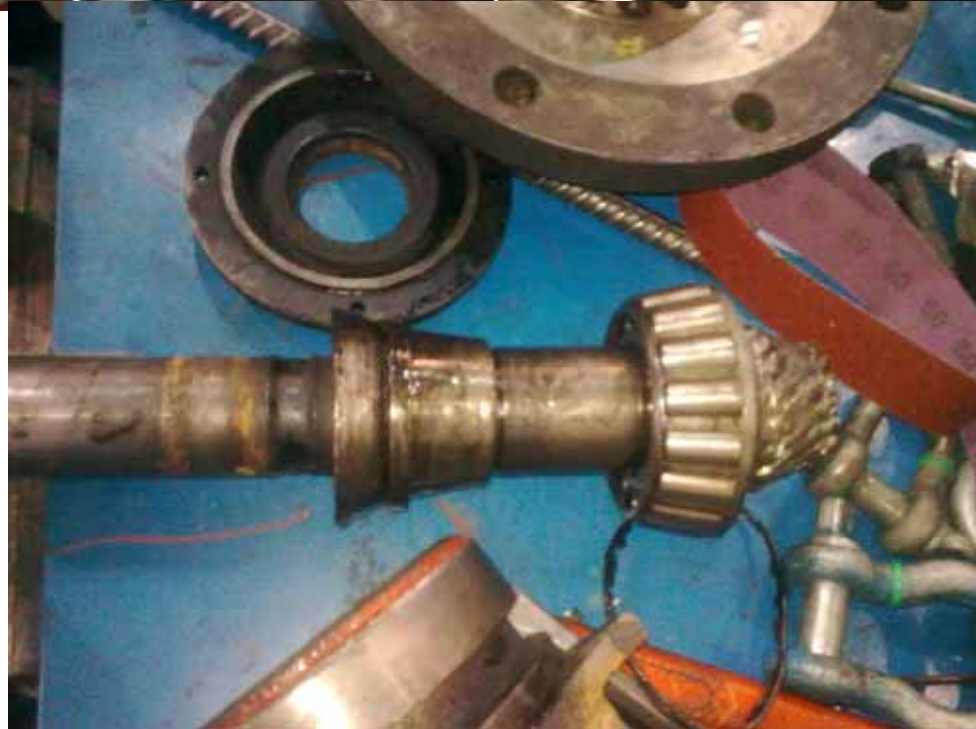
# Photos during investigation

- 
- Gearbox was send for repairs.
  - QC not up to standard.
  - QC component document was a Paper exercise.
  - Didn't use correct components (human Factor).
  - Power Pack returned to SWC.
  - Power pack installed.
  - Inspection done by fitter on shift.
  - Due to vibration and thrust and situation caused by human error bolts vibrated loose and input pinion bearing cover came loose causing oil starvation (12min) and gearbox failure with in 3min of oil drainage.
  - Exchange Power Pack.
  - Failure again due to human error (motor single phase).
  - Replace Power pack.
  - Commissioning - Production

- SWC
  - Maintenance Regularly.
  - Inspection on all the input pinion cover bolts.
  - Oil Samples.
  - Vibration and Thermal monitoring.
- DB
  - New service centre dedicated to repairs. Costing R12M.
  - Proper QC assurance.
  - More focused management of QC list and components.
