Testing of a ROPS of a tractor with a flame proof canopy

11249 AIM (Testing of tractor ROPS)

Document No: IM-TR348

This report presents the results of conformance testing that was done on the ROPS of a tractor that is equipped with a flame proof canopy for use in a coal mine. The test was done according to the ISO 3471 standard.

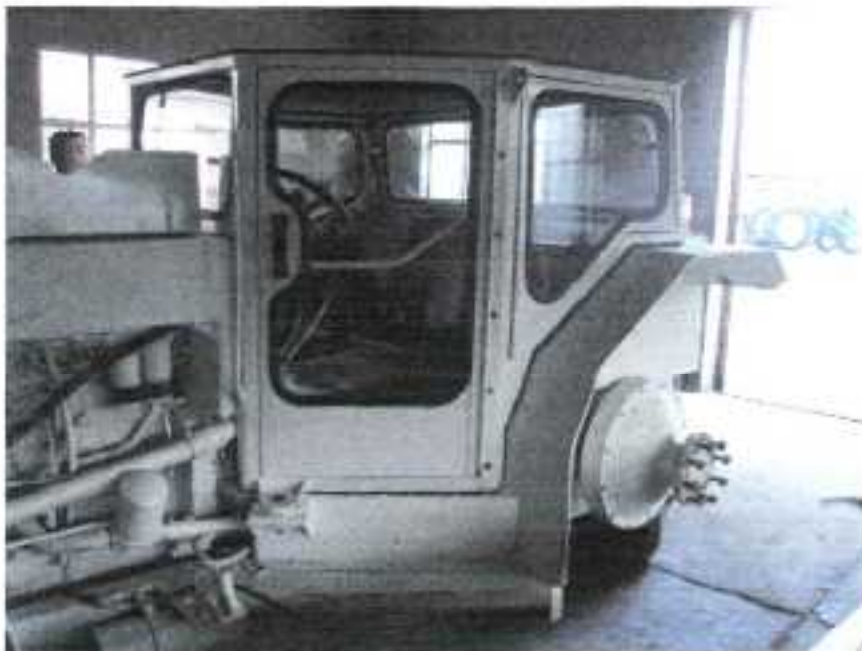
Figure 1. Tractor with enclosed cabin – manufactured for use in the mining industry.

Mr. Hans Fourie of AIM Off Road Equipment contracted Investmech to test a Roll Over Protective Structure (ROPS) of a tractor according to the requirements of the ISO 3471 standard. The ROPS is designed to be mounted behind the fully enclosed cabin of the tractor and connects directly to the machine frame of the tractor. The tractor cabin is shown in the photograph in Figure 1. For the purpose of the test the ROPS was mounted rigidly to the test floor. The test loads were applied using a hydraulic jack and the force magnitude was measured with a 20 ton load cell with serial number 49854 connected to a strain amplifier with serial number 170011. An inductive displacement transducer was used to measure the deflection of the ROPS. The remainder of this report describes the test method and presents the test results.

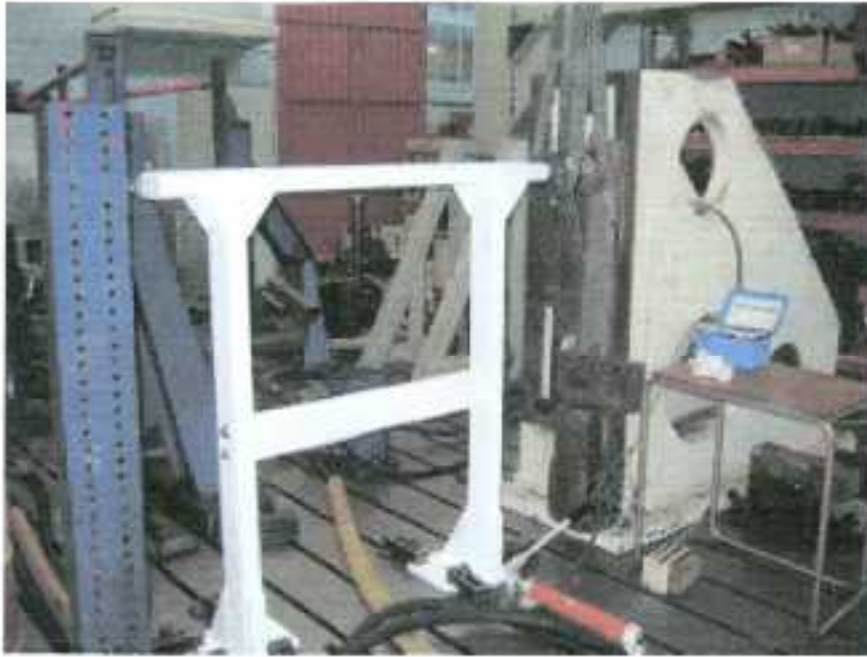
The lateral load was applied in increments of 5kN at the upper corner of the ROPS frame and the resulting deflection of the ROPS was measured in line with the point of load application. The energy absorbed by the ROPS was calculated as the test progressed. The lateral load force requirement of 32.88kN was met with a total lateral deflection of 22mm. The total energy absorbed by the ROPS at this stage was 400J. Loading was continued in increments of 5 kN up to 80kN at which point plastic deformation started. From this point onwards the plastic yielding of the ROPS would have resulted in large displacements associated with a 5kN load increment and therefore further data points were collected at fixed displacement increments. The lateral load energy requirement of 5,893J was reached at an applied load of 83.2kN and a total deformation of 111.1mm. There was no penetration of the ROPS or the lateral simulated ground plane into the DLV. The test data is presented in graphic format in Figure 4 in Appendix A. In the figure the requirement of total energy absorbed is represented by the horizontal yellow line. The intersection of the cumulative energy line (blue line) and the horizontal yellow line represents the point of conformance to the lateral energy absorption requirement of the ISO 3471 standard. The penetration of the ROPS and the lateral simulated ground plane into the DLV was evaluated under the load and deflection conditions corresponding to this point of intersection. The test set-up for the lateral load test of the ROPS at an applied load of 30kN is shown in Figure 2 below.

Figure 2. ROPS under load during the lateral load test.

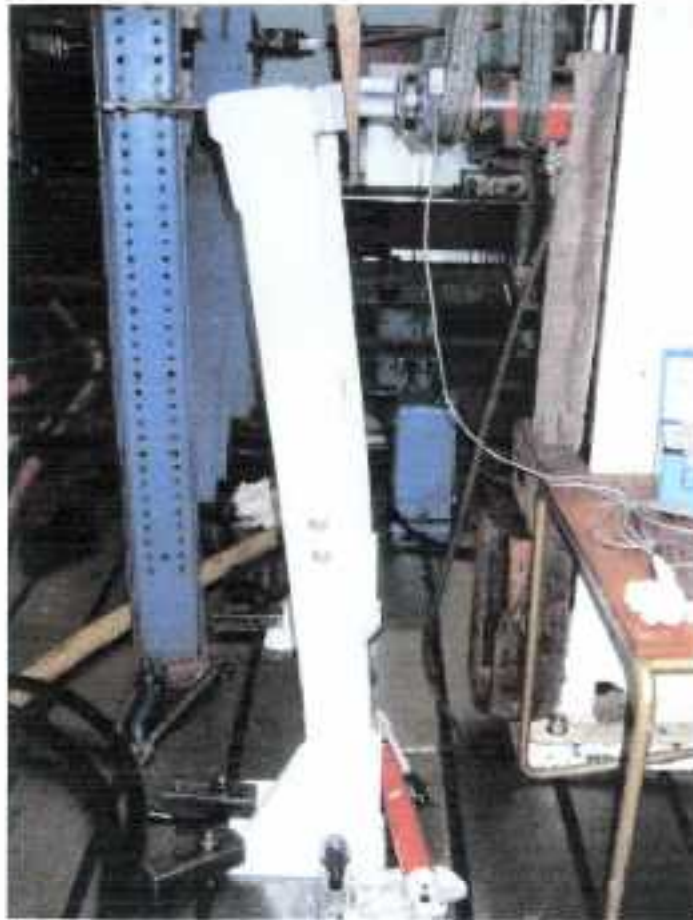
The longitudinal load was applied in increments of 5kN via a load spreading interface that spanned less than 80% of the width of the ROPS. The resulting deflection of the ROPS was measured in line with the point of load application. The energy absorbed by the ROPS was calculated as the test progressed. The lateral load force requirement of 26.3kN was met with a total lateral deflection of 14mm. The total energy absorbed by the ROPS at this stage was 200J. Loading was continued in increments of 5kN up to 70kN at which point plastic deformation started. From this point on the plastic yielding of the ROPS would have resulted in large displacements associated with a 5kN load increment and therefore further data points were collected at fixed displacement increments. The lateral load energy requirement of 7,672J was reached at an applied load of 78kN and a total deformation of 137.3mm. There was no penetration of the ROPS or the longitudinal simulated ground plane into the DLV. The test data is presented in graphic format in Figure 5 in Appendix A. In the figure the requirement of total energy absorbed is represented by the horizontal yellow line. The intersection of the cumulative energy line (blue line) and the horizontal yellow line represents the point of conformance to the longitudinal energy absorption requirement of the ISO 3471 standard. The penetration of the ROPS and the longitudinal simulated ground plane into the DLV was evaluated under the load and deflection conditions corresponding to this point of intersection. The test set-up for the lateral load test of the ROPS at an applied load of 75.1kN is shown in Figure 3 below.

Figure 3. ROPS under load during the longitudinal load test.

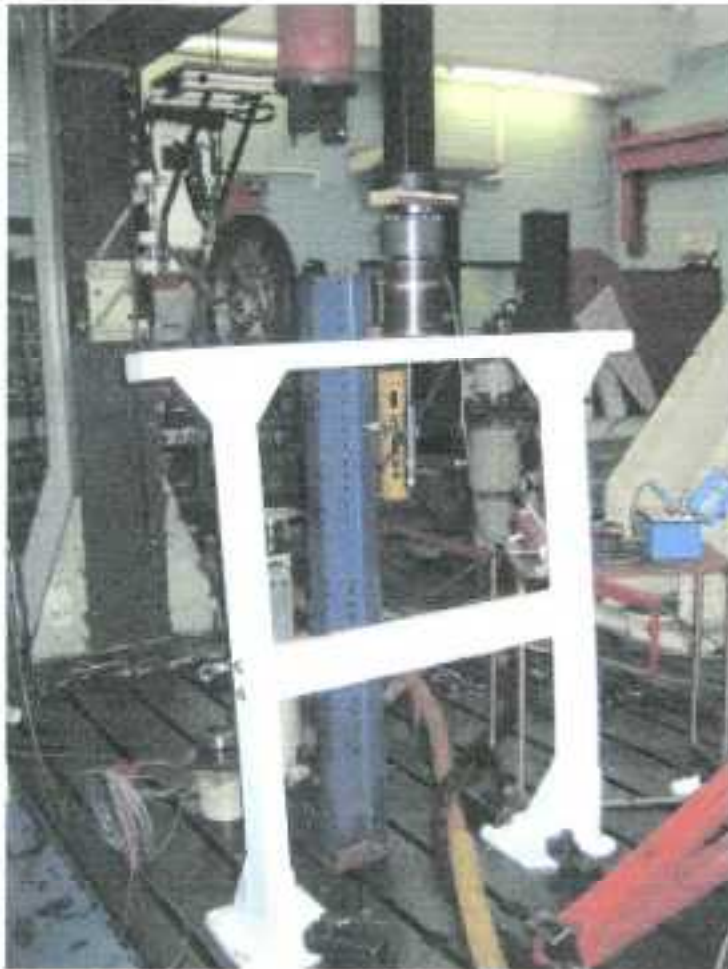
The vertical test load was applied in the centre of the upper ROPS cross member. The required vertical load of 107.5kN was applied and a total vertical displacement of 12mm was measured in line with the applied load. The ROPS did not penetrate the rearward projection of the deflection limiting volume under maximum applied vertical load. The test set-up for the lateral load test of the ROPS is shown in Figure 3 below.

Table 2. Test set-up for the vertical load test.

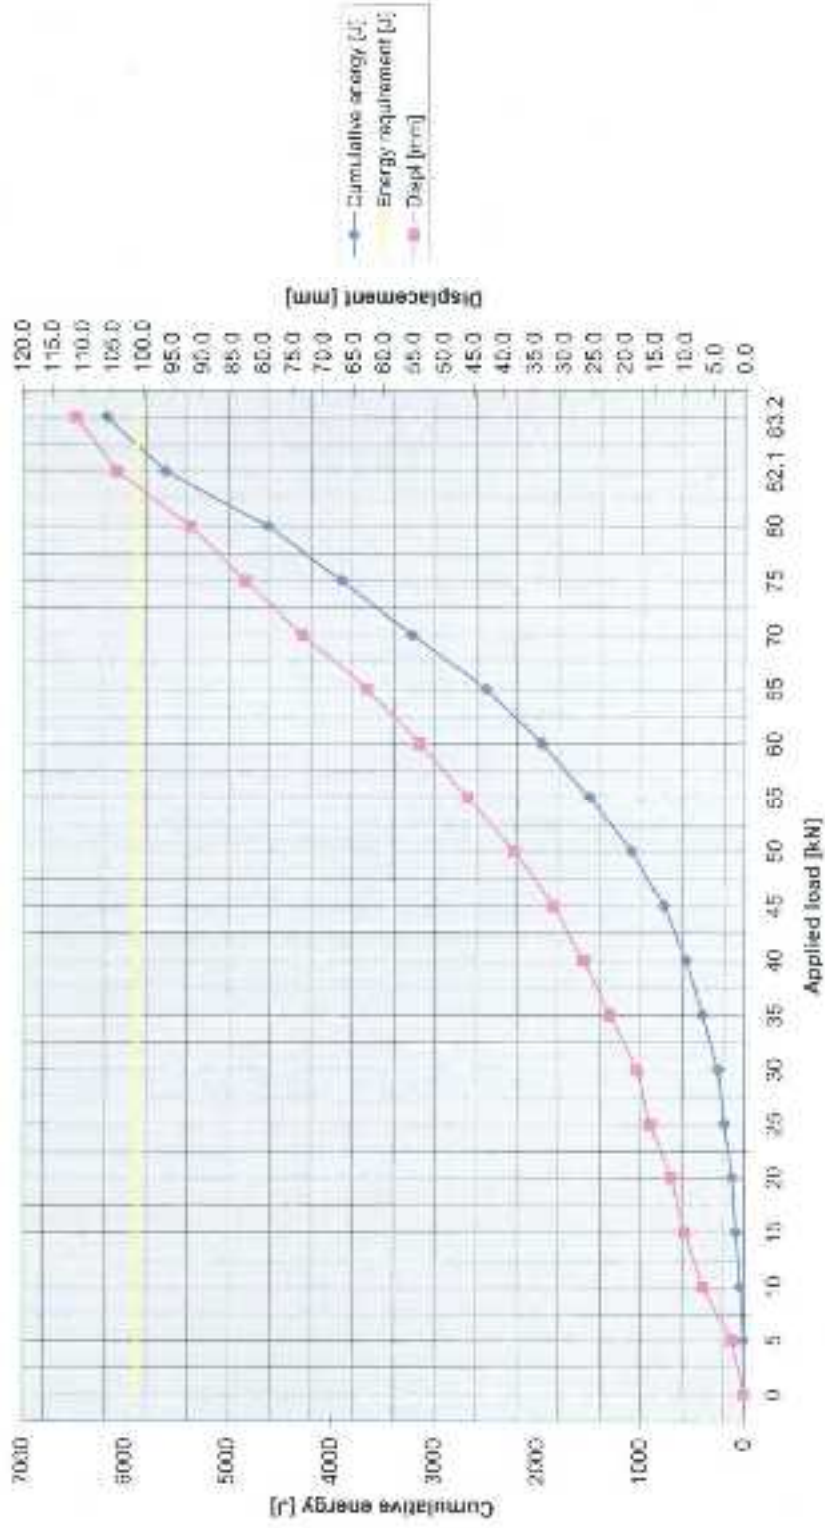
Figure 4. Lateral load test data.

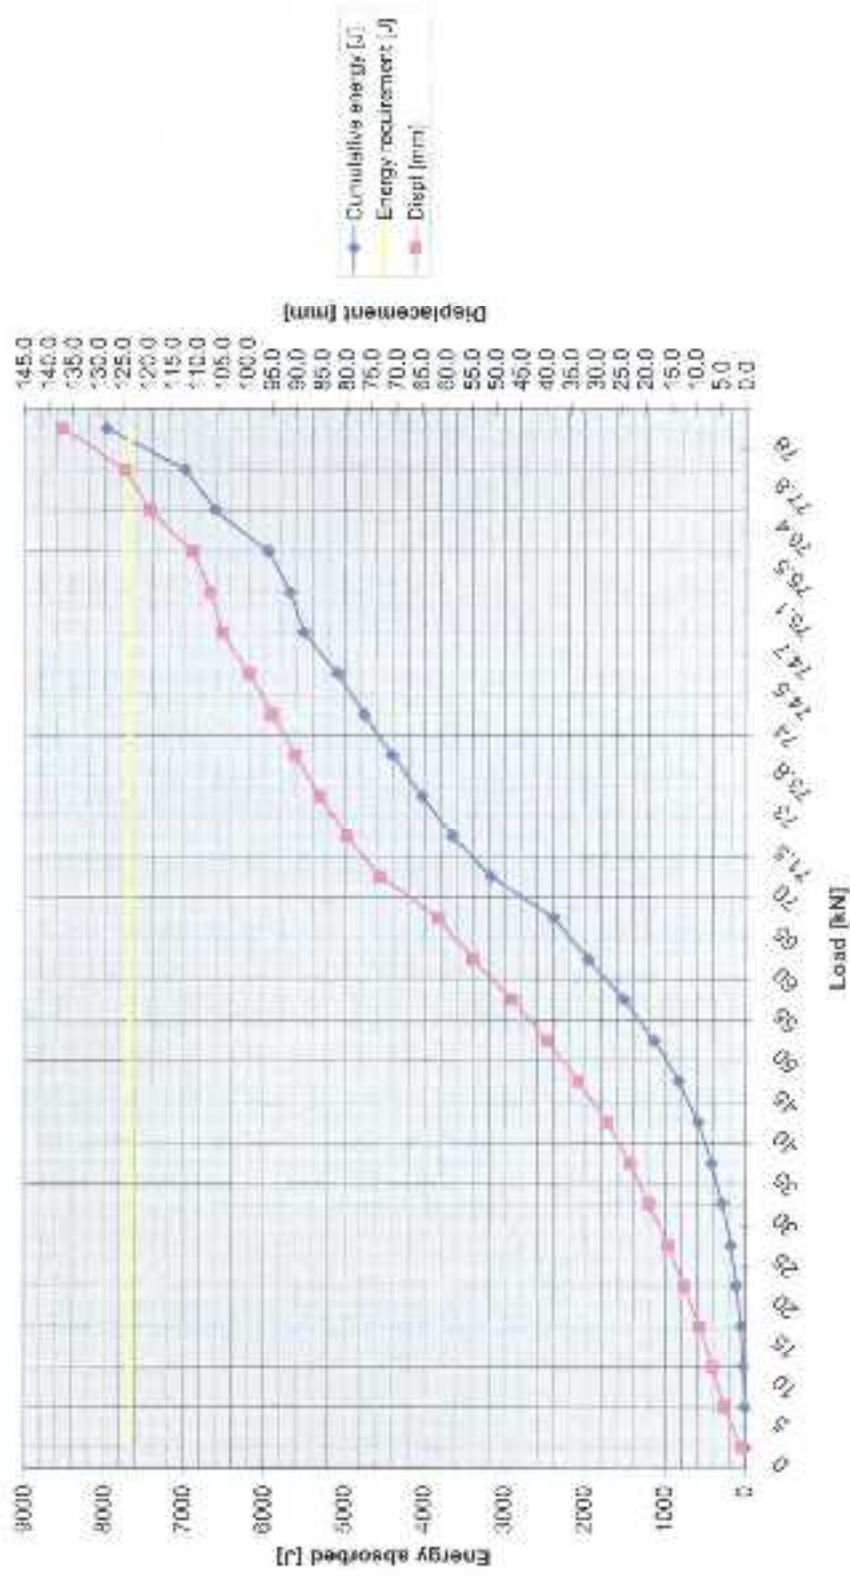
Figure 5. Longitudinal load test data.
