# SWC Dawid Brown Catastrophic Failure

21 January 2010

Compiled by: P.J. Du Preez

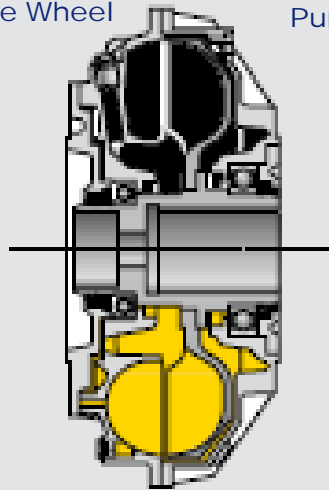
## Standstill

All the fluid in the coupling is at rest.

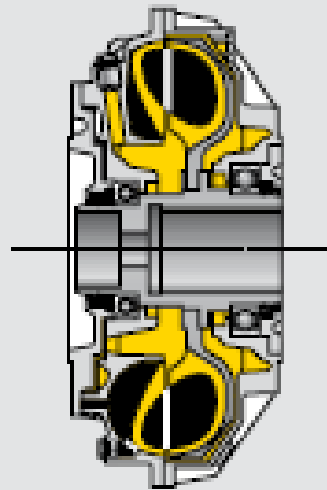
## Start-up

With increasing speed, the operating fluid in the working circuit is accelerated via the pump wheel. The circulatory flow created in this way is supported by the turbine wheel and sets the latter in motion. The torque development is determined by the characteristic curve of the coupling, while the start-up characteristics are influenced by an appropriate arrangement of compensating chambers (delay chamber, annular chamber).

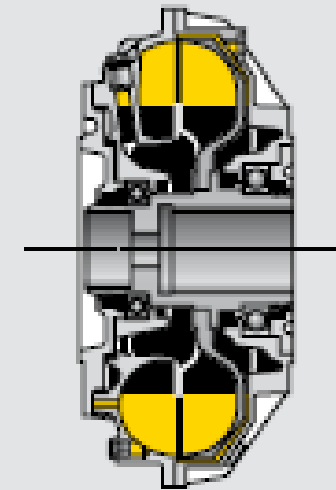
## Nominal Operation

The low speed difference between pump and turbine wheel (the so called nominal slip) leads to the flow condition in the coupling becoming stationary. Only the torque required by the driven machine is transmitted.
